Manhole Inspection Summary

Manhole # S17M__017MH

Insp Date: **4/21/09 11:06 AM**

Location Address: **2401 FREDERICK AV**

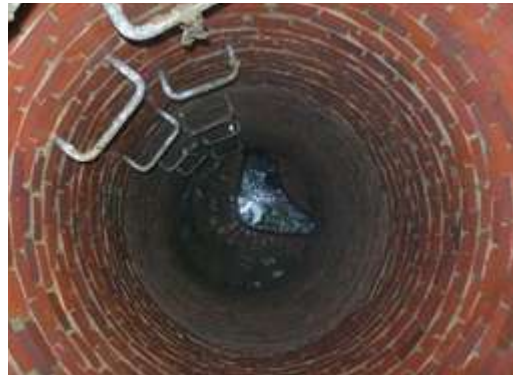
Top View

Bench ☒ Exists Material: **Brick** ☐ Parged
Condition: ☐ Sound ☐ Cracked ☐ Root Intrusion ☐ Deteriorated ☐ Leaks ☒ **Debris**

Channel Material: **Brick** ☐ Parged
Channel Exposure: **Fully Open** Junc Dist: **0** nearest .5 ft. Azimuth: **0**
Condition: ☐ Sound ☐ Cracked ☐ Root Intrusion ☐ Deteriorated ☐ Leaks ☒ **Debris**
